MATERIALS LIFE: UMA FERRAMENTA PARA A ANÁLISE METALÚRGICA DE FALHAS

Annelise Zeemann
annelise@materials.life

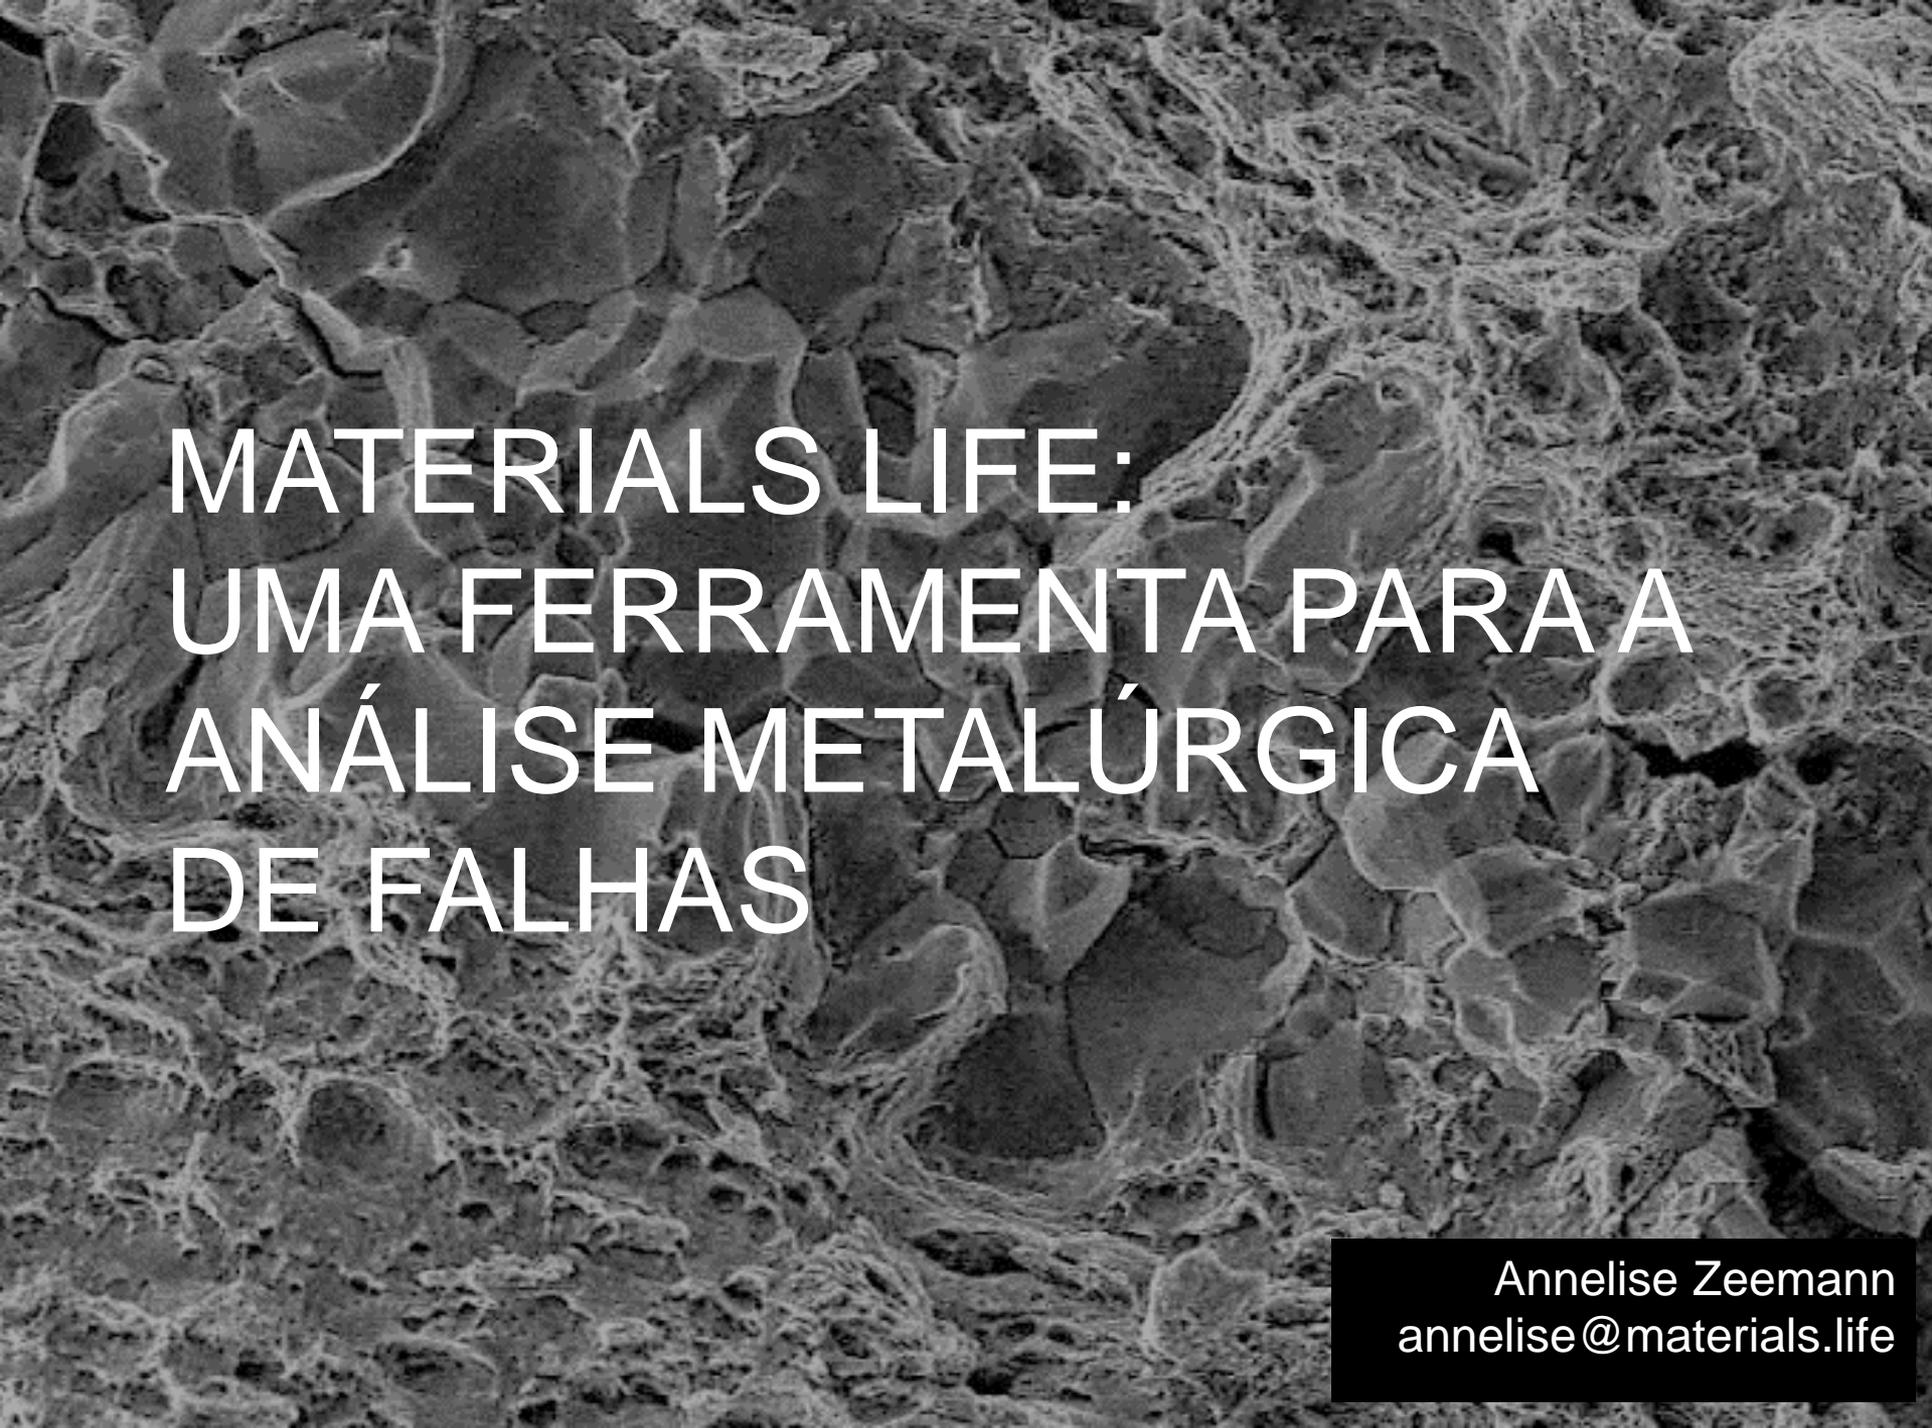
The background of the slide is a grayscale scanning electron microscope (SEM) micrograph of a metal fracture surface. The image shows a complex, porous, and fibrous structure, characteristic of a ductile fracture process. The surface is highly textured with various sized particles and interconnected fibers, creating a rough, irregular appearance. The lighting highlights the three-dimensional nature of the fracture, with some areas appearing more prominent than others.

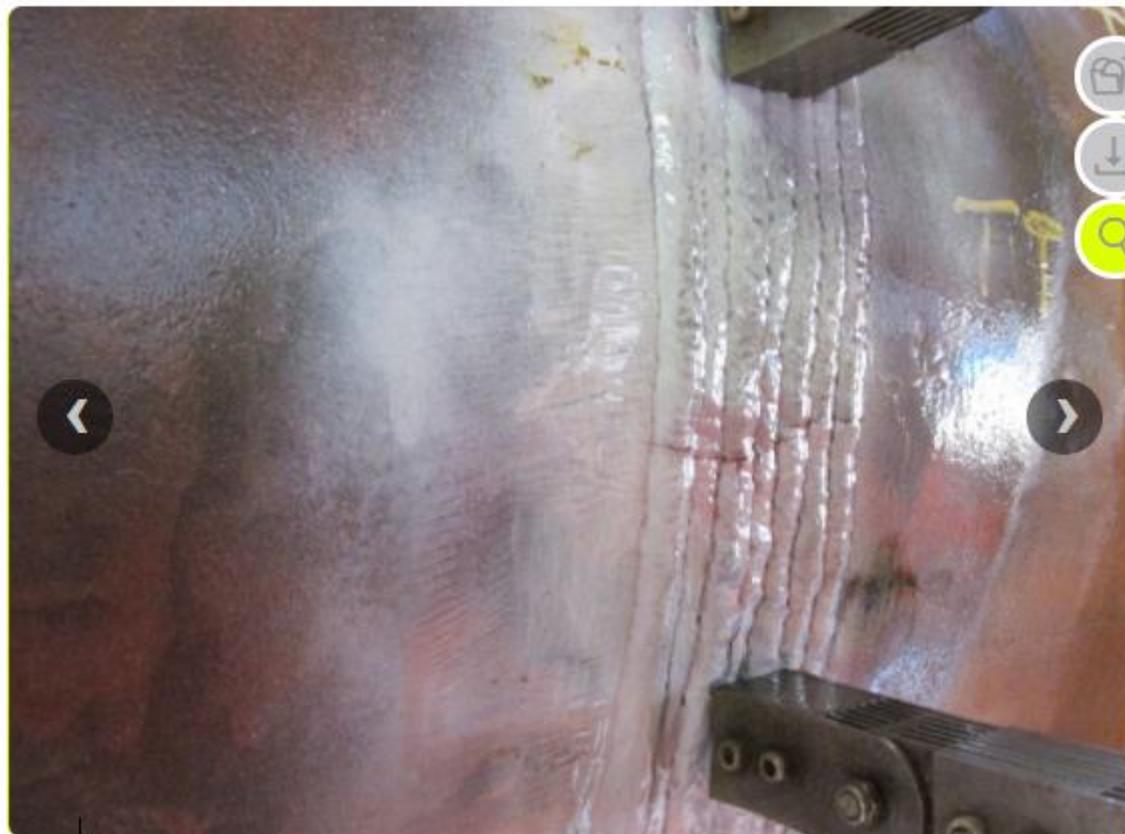
1 **Cm** - Aspect by NDT **Df** - Cracks

Image of the magnetic particle test, using a white contrast, presenting the cracks at the surface of the weld metal. The cracks are transverse to the weld and do not propagate into the base metals. A forged T in the

Reheating Cracking of a CrMo Vessel Weld

M - CrMo Steel **P** - In Field Weld **Ap** - Energy **Cd** - Welding Defect

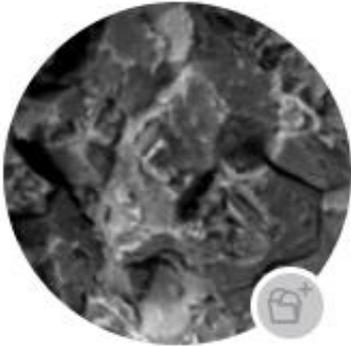
ML00009 / Sep.2017

Hydrogen Cracking of a 5" Drill Pipe S135

M - Low Alloy Medium Carbon QT
P - Drill Pipe
Ap - Subsea
Cd - Hydrogen Embrittlement

Cm - Fractography by SEM
Df - Intergranular Cracking

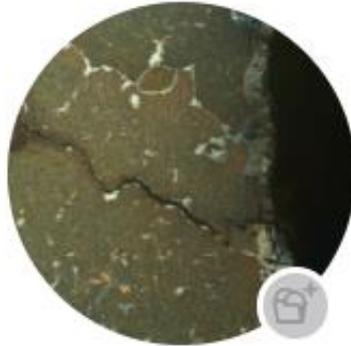
ML00042 / Apr.2017

Gas Turbine Blade IN 939, Coated

M - NiCrCo Alloy
P - Cast
Ap - Gas Turbine
Cd - Intergranular Cracking

Cm - H2SO4+HNO3+H3PO4 Etched Micro
Df - Intergranular Cracking

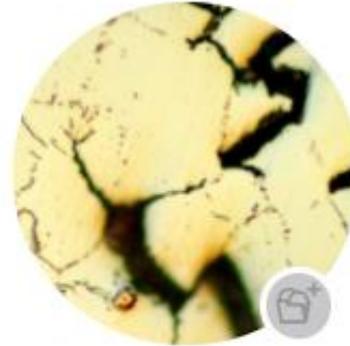
ML00075 / Dec.2017

Hydrogen Cracking of IN 718 Subsea Fasteners

M - NiCrFe Alloy
P - Bolt
Ap - Subsea
Cd - Hydrogen Embrittlement

Cm - Kalling Etched Micrography by OM
Df - Intergranular Cracking

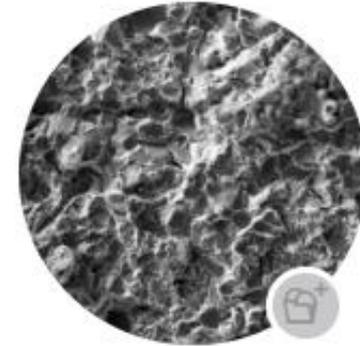
ML00127 / Mar.2018

Hydrogen Cracks of Cadmium Plated Studs

M - Low Alloy Medium Carbon QT
P - Allen Stud
Ap - Oil and Gas
Cd - Hydrogen Embrittlement

Cm - Fractography by SEM
Df - Intergranular Cracking

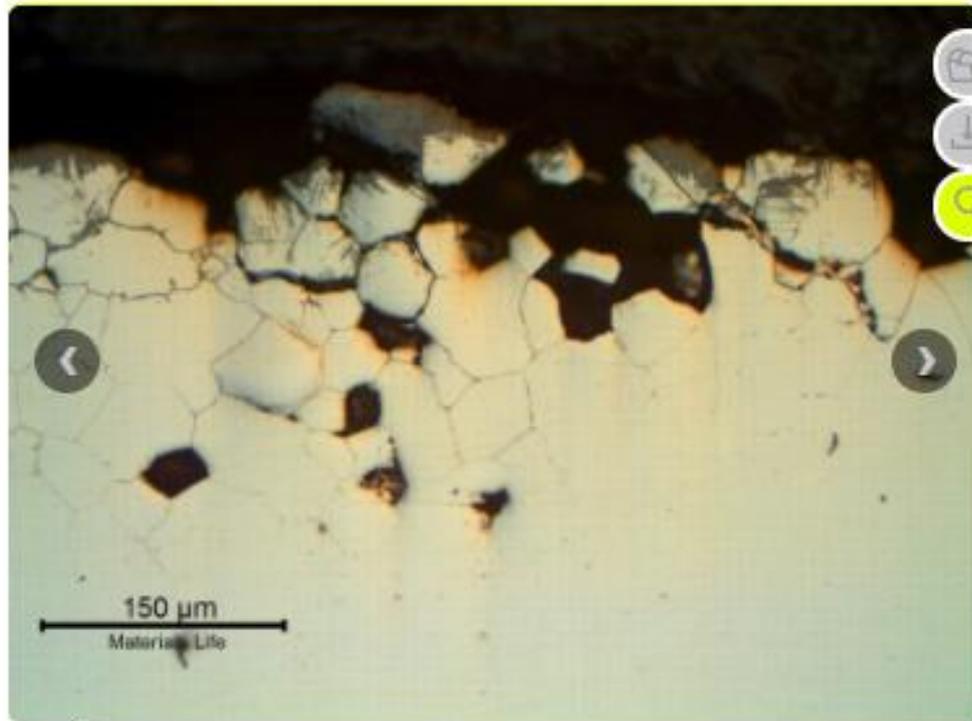
1 [Cm - Micrograph by DM](#) [Df - Intergranular Corrosion](#)

The micrograph of the transverse section of the plate, as polished, close to the surface. The material presents intergranular corrosion and some grains were lost.

The WHRU duct was operating at 485°C and after several years in service the plate material presented local damage and a repair welding was conducted. During repair, several cracks appear adjacent to the weld. The metallurgical investigation indicated that the plate has been sensitized during service and suffered intergranular corrosion in several locations along the surface. The stresses imposed by the repair welding in these embrittled regions (with intergranular corrosion) opened the cracks.

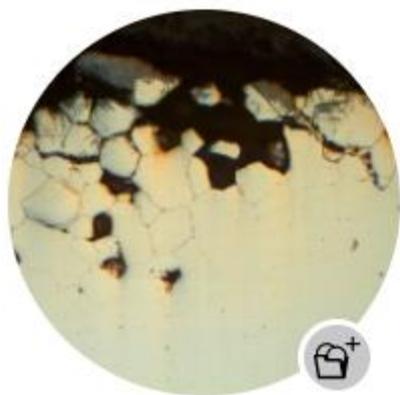
Cm - Micrography by OM
Df - Intergranular Corrosion

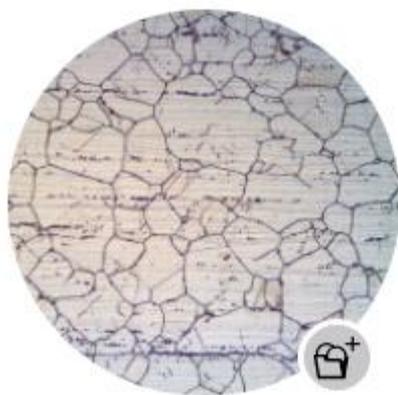
Cm - Micrography by OM using A262 Method A
Df - Intergranular Precipitation

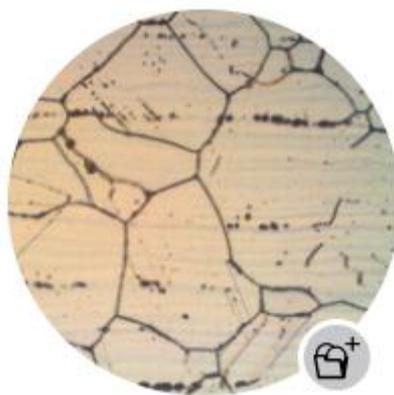
Cm - Micrography by OM using A262 Method A
Df - Intergranular Precipitation

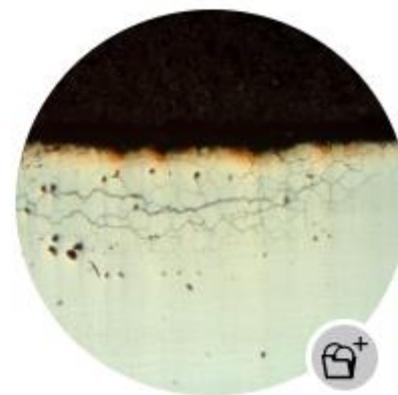
Cm - Micrography by OM
Df - Intergranular Corrosion

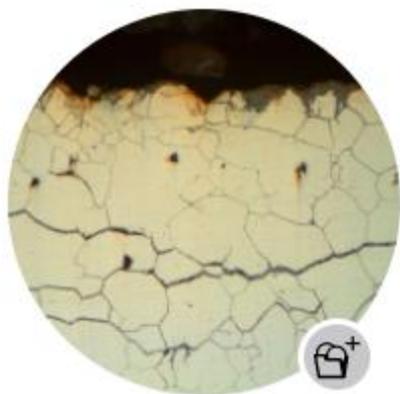
Cm - Micrography by OM
Df - Intergranular Corrosion

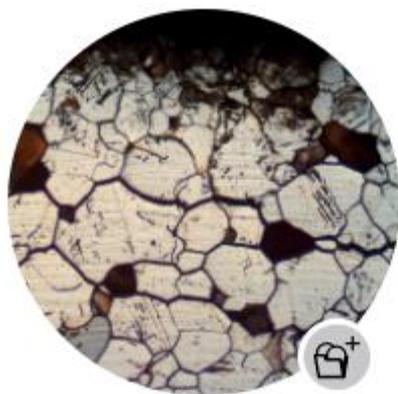
Cm - Micrography by OM using A262 Method A
Df - Intergranular Corrosion

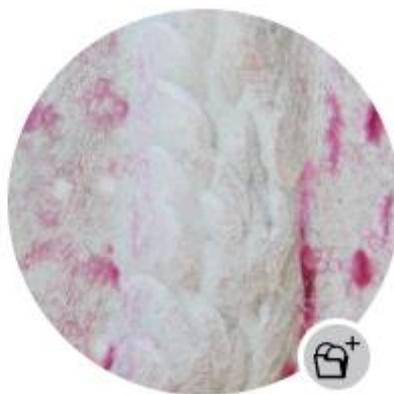
Cm - Aspect by NDT
Df - At the Surface

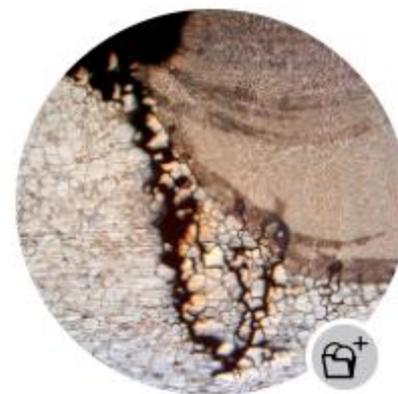
Cm - Micrography by OM using A262 Method A
Df - Intergranular Cracking

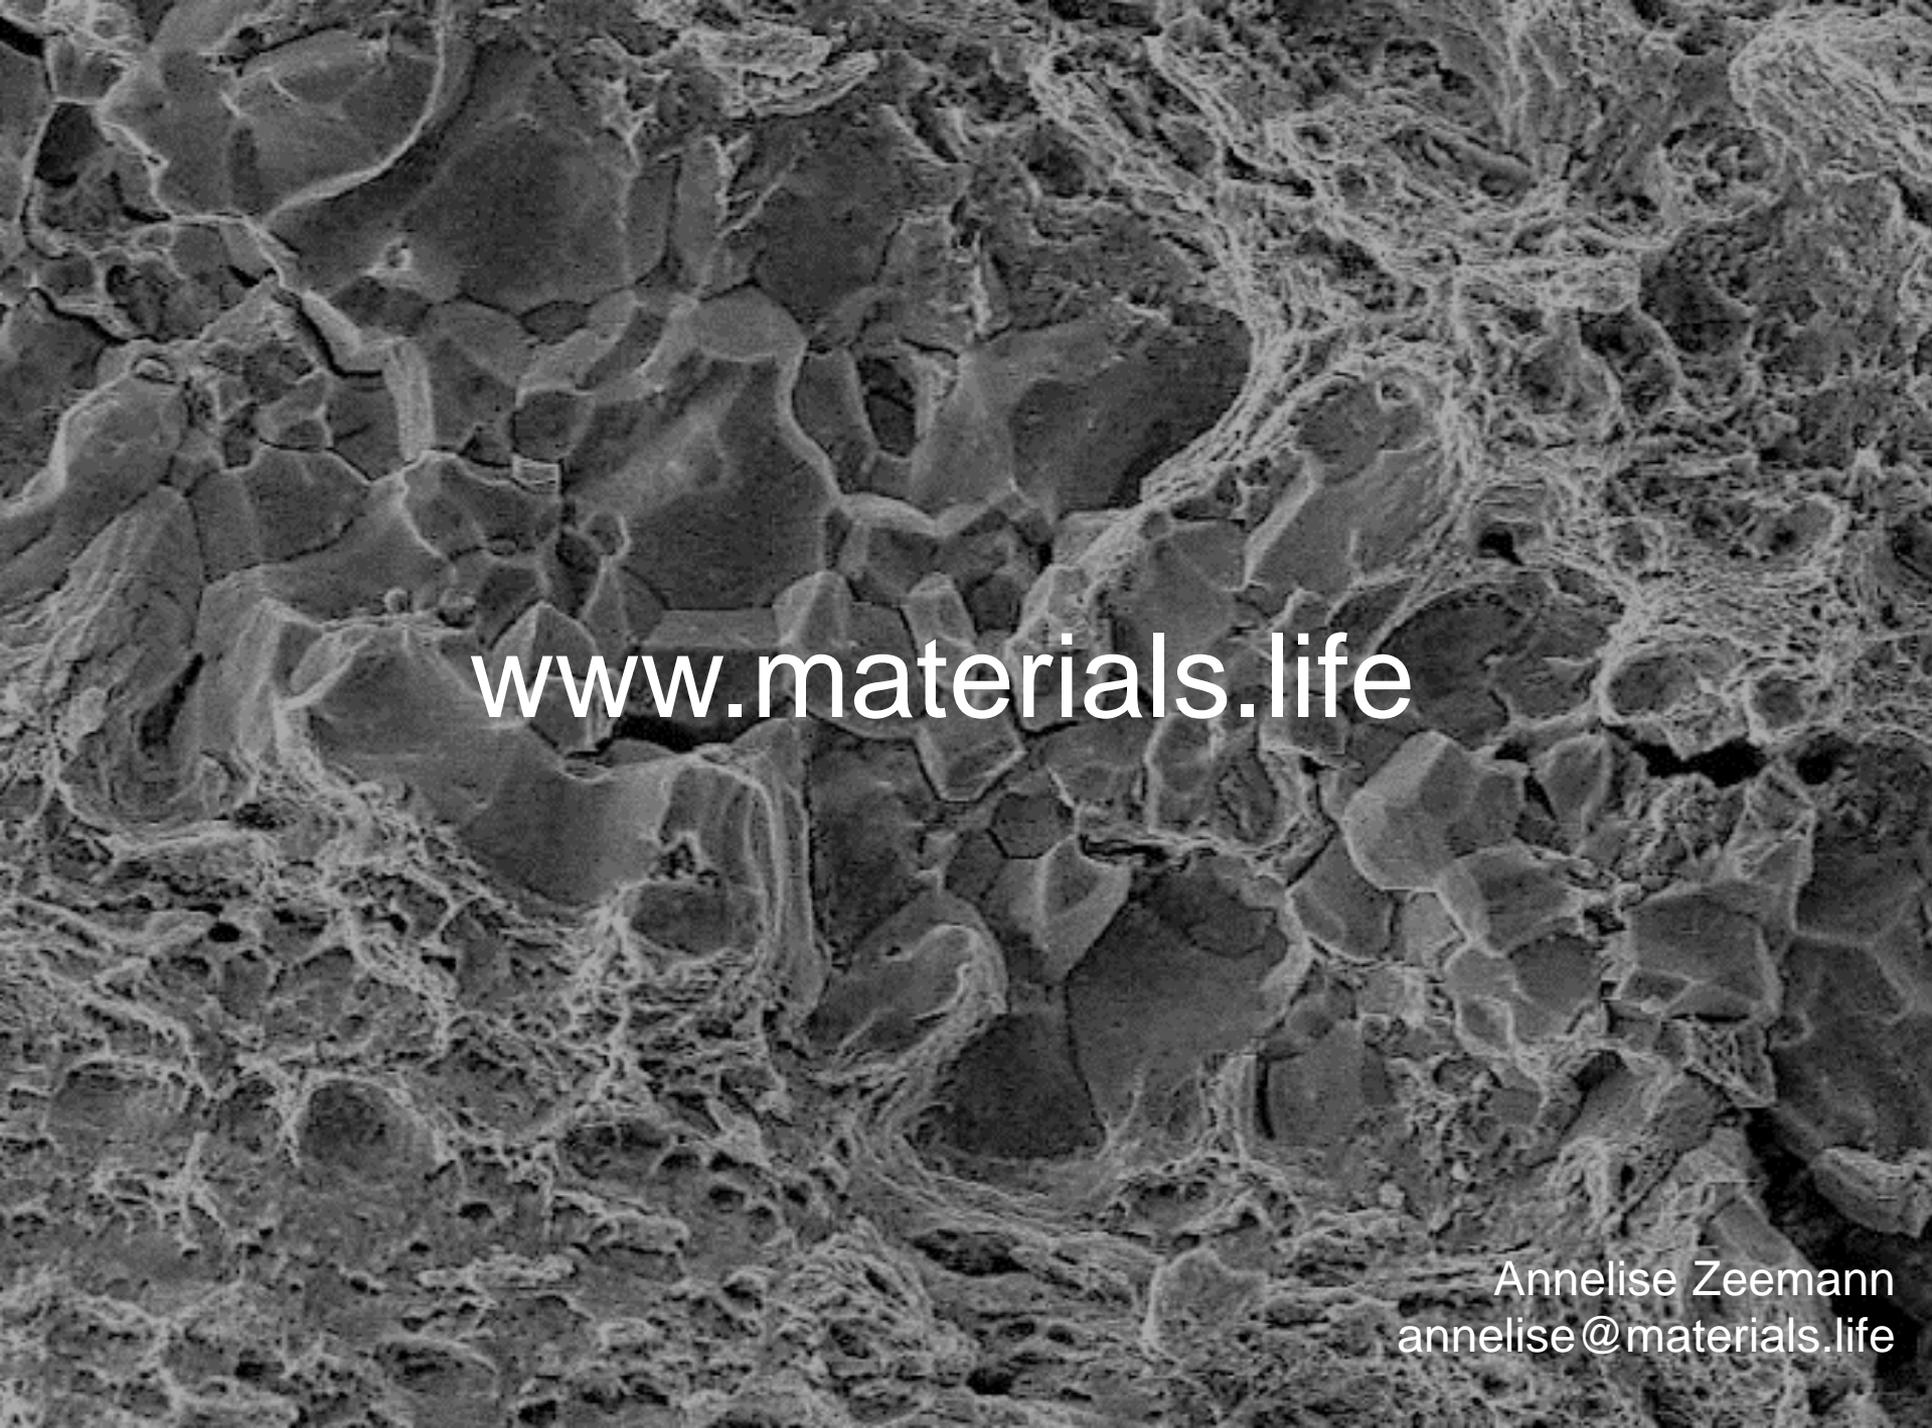
The background of the image is a scanning electron micrograph (SEM) showing a complex, porous, and cracked surface structure. The material appears to have a cellular or honeycomb-like morphology with irregular, interconnected cells and a network of fine cracks. The overall texture is rough and highly detailed.
